**BULK ASBESTOS SURVEY REPORT  
BAY AGGREGATE SITE  
NORTH WATER STREET  
BAY CITY, MICHIGAN**

**CITY OF BAY CITY**

**AKT PEERLESS PROJECT NO. 3522F-4-190  
NOVEMBER 18, 2002**

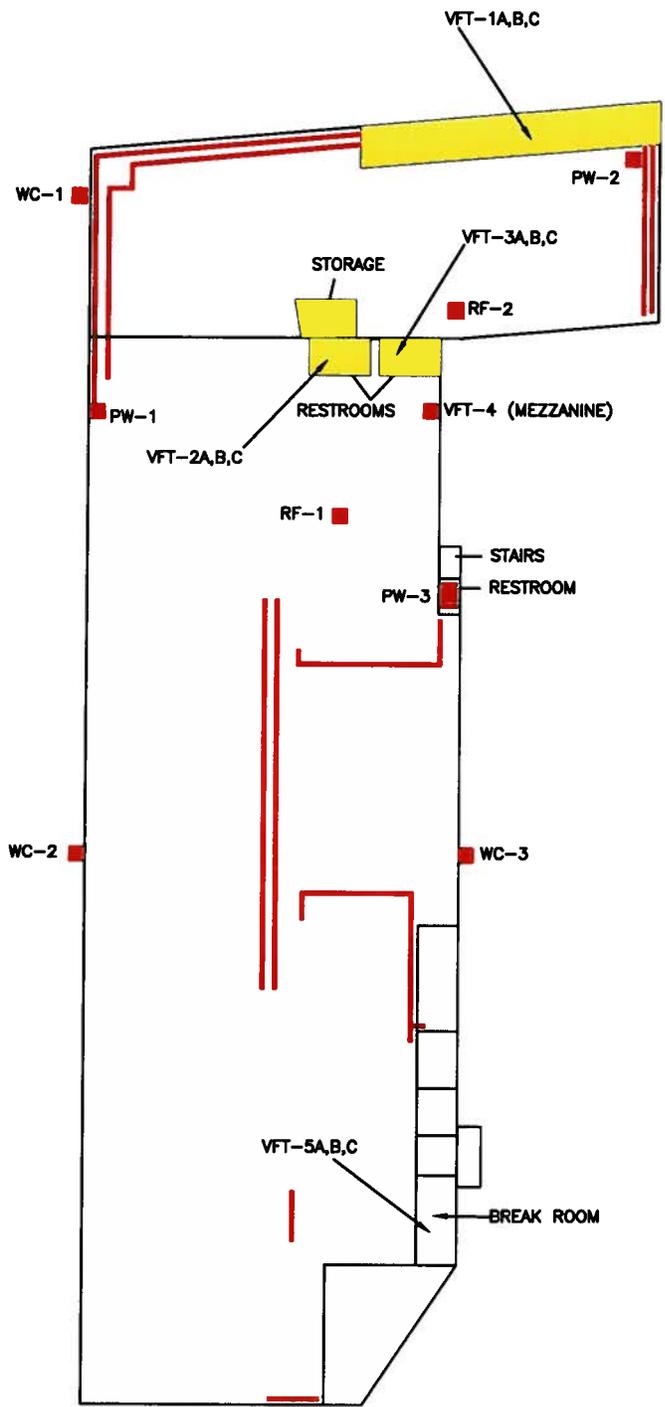
**FIGURE 2**

<b>Building A</b>				
<b>Material and Location</b>	<b>Approximate Quantity</b>	<b>Physical Condition</b>	<b>Sample ID</b>	<b>Percent Asbestos Content (%)</b>
Tan 12-inch by 12-inch vinyl floor in northwest office	3,200 sq. ft.	Fair to Good Non-Friable	VFT-1A VFT-1B VFT-1C	2 % tile; 5 % mastic 2 % tile; 5 % mastic 2 % tile; 5 % mastic
Brown 9-inch by 9-inch vinyl floor in north central restroom	250 sq. ft.	Fair to Good Non-Friable	VFT-2A VFT-2B VFT-2C	3 % tile; NAD mastic 3 % tile; NAD mastic 3 % tile; NAD mastic
Light brown 12-inch by 12-inch vinyl floor in northwest office	650 sq. ft.	Fair to Good Non-Friable	VFT-3A VFT-3B VFT-3C	2 % tile; 2 % mastic 2 % tile; 2 % mastic 2 % tile; 2 % mastic
Green 9-inch by 9-inch vinyl floor in east mezzaanine	50 sq. ft.	Fair to Good Non-Friable	VFT-4	3 % tile; NAD mastic
Brown 12-inch by 12-inch vinyl floor tile in southeast breakroom	700 sq. ft.	Fair to Good Non-Friable	VFT-5A VFT-5B VFT-5C	<1 % tile; NAD mastic <1 % tile; NAD mastic <1 % tile; NAD mastic

2-foot by 4-foot suspended ceiling tile in northwest office	1,600 sq. ft.	Poor to Good Friable	SCT-1A SCT-1B SCT-1C	NAD NAD NAD
2-foot by 4-foot suspended ceiling tile in southeast breakroom	700 sq. ft.	Fair to Good Friable	SCT-2A SCT-2B SCT-2C	NAD NAD NAD
Thermal pipe wrap insulation in various areas of building	1,500 linear feet	Poor to Good Friable	PW-1 PW-2 PW-3	85 % 85 % 85 %
Asphalt roofing on various areas of building	Undertermined	Fair to Good Non-Friable	RF-1 RF-2	NAD 90 %
Caulking on majority of windows	Undertermined	Poor to Good Friable	WC-1 WC-2 WC-3	2 % 2 % 2 %

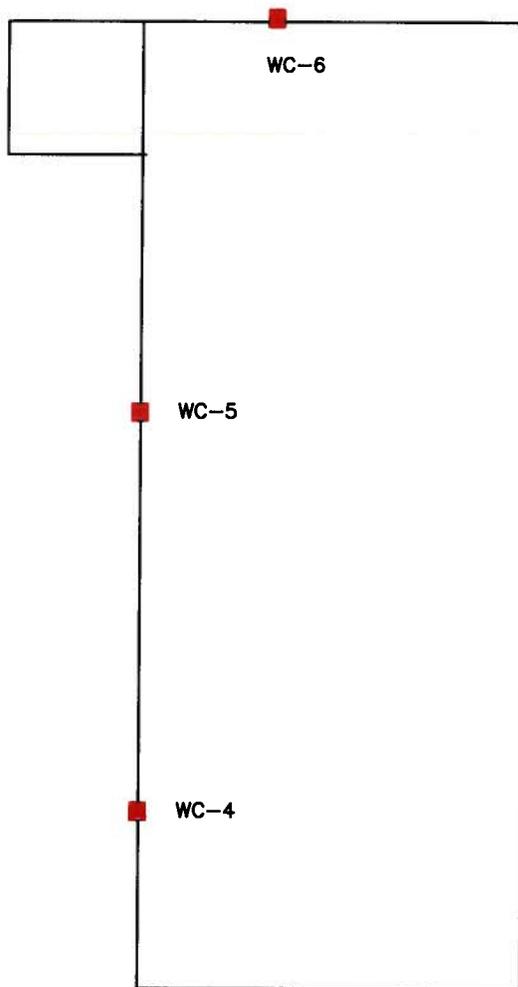
**FIGURE 3**

<b>Building B</b>				
<b>Material and Location</b>	<b>Approximate Quantity</b>	<b>Physical Condition</b>	<b>Sample ID</b>	<b>Percent Asbestos Content (%)</b>
Caulking on majority of windows	Undertermined	Poor to Good Friable	WC-4 WC-5 WC-6	2 % 2 % 2 %

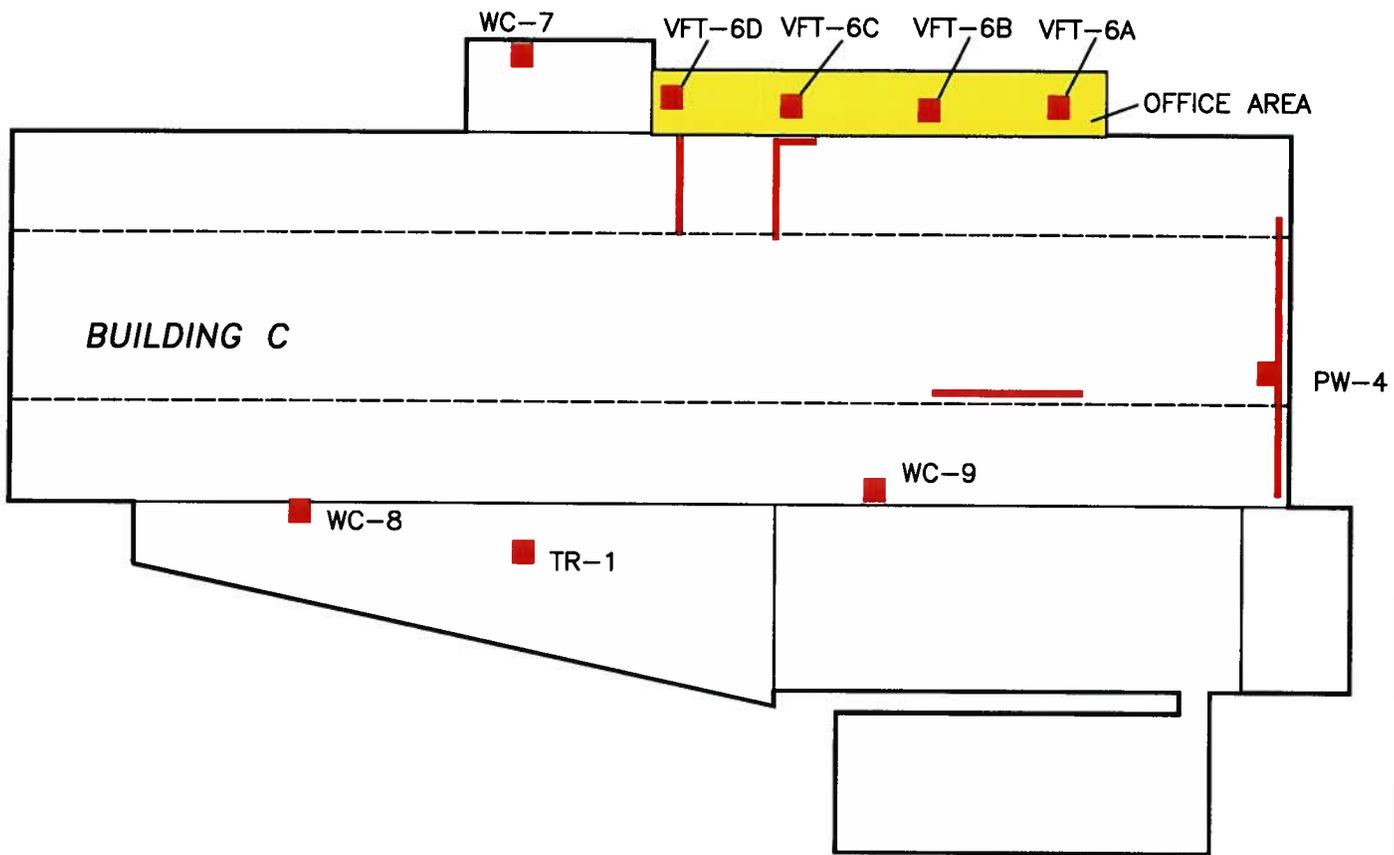
**FIGURE 4**

<b>Building C</b>				
<b>Material and Location</b>	<b>Approximate Quantity</b>	<b>Physical Condition</b>	<b>Sample ID</b>	<b>Percent Asbestos Content (%)</b>
Brown 9-inch by 9-inch vinyl floor in northeast office	2,200 sq. ft.	Fair Non-Friable	VFT-6A VFT-6B VFT-6C VFT-6D	5 % tile; NAD mastic 5 % tile; NAD mastic 5 % tile; NAD mastic 5 % tile; 5 % mastic
Thermal pipe wrap insulation in various areas of building	300 linear feet	Poor to Good Friable	PW-4	85 %
Caulking on majority of windows	Undertermined	Poor to Good Friable	WC-7 WC-8 WC-9	2 % <1 % <1 %
Transite roofing and siding on southern portion of building	4,500 sq. ft.	Fair to Good Non-Friable	TRP-1	20 %

**NO SUSPECT ACBMS IDENTIFIED**

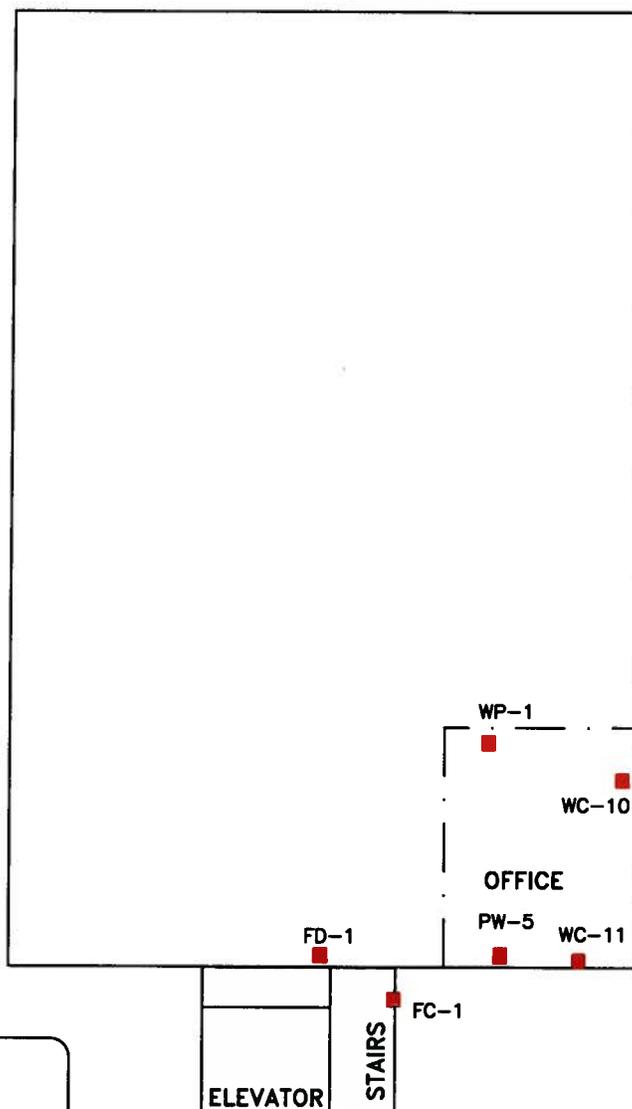
**FIGURE 5**

<b>Building D</b>				
<b>Material and Location</b>	<b>Approximate Quantity</b>	<b>Physical Condition</b>	<b>Sample ID</b>	<b>Percent Asbestos Content (%)</b>
Thermal pipe wrap insulation in southeast office	15 linear feet	Poor to Good Friable	PW-5	85 %
Wall plaster in southeast office	500 sq. ft.	Poor to Good Friable	WP-1	NAD
Asphalt covered felt over metal panels on stairwell and elevator enclosure	2,500 sq. ft.	Good Non-Friable	FC-1	85 %
Fire doors on all floors	8 doors	Good Non-Friable	FD-1	NAD
Caulking on majority of windows	Undertermined	Fair to Good Non-Friable	WC-10 WC-11	NAD 2 %
